**Enbridge Line 6B MP 608 Pipeline Release
Marshall, Michigan**

**Permanent Recovery of Submerged Oil and Oil-Contaminated
Sediments at Priority Locations**

Submerged Oil Recovery Summary Report

**Enbridge Energy
October 29, 2010**

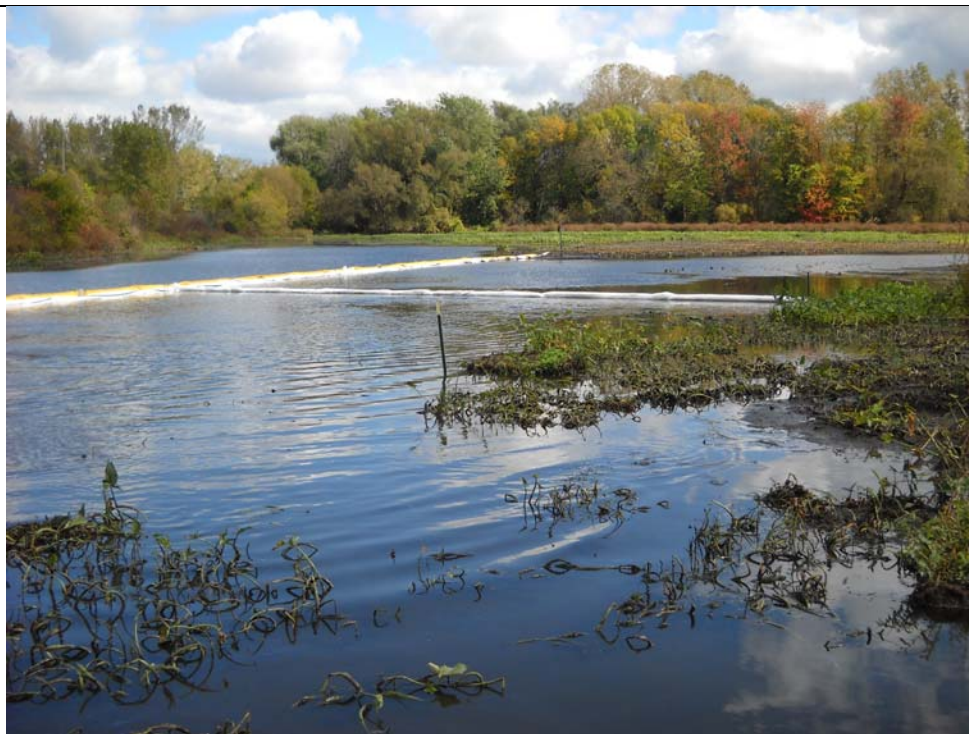
Photograph 3

Description:
Recovery activities in progress – hard and soft boom deployed

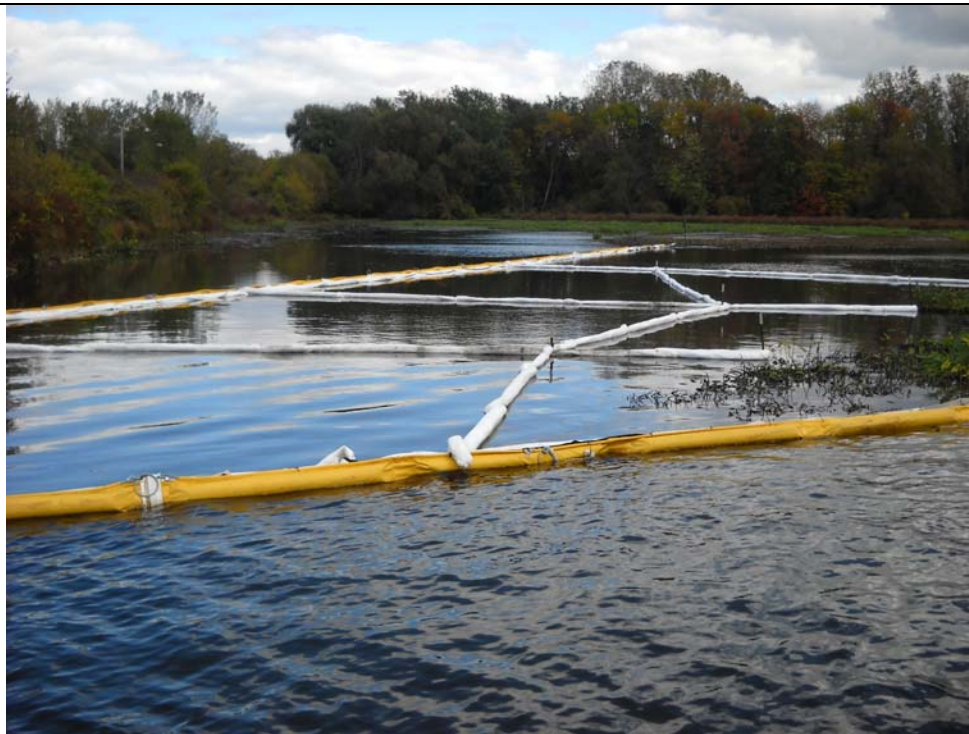
Photograph 4

Description:
Recovery activities in progress – hard and soft boom deployed

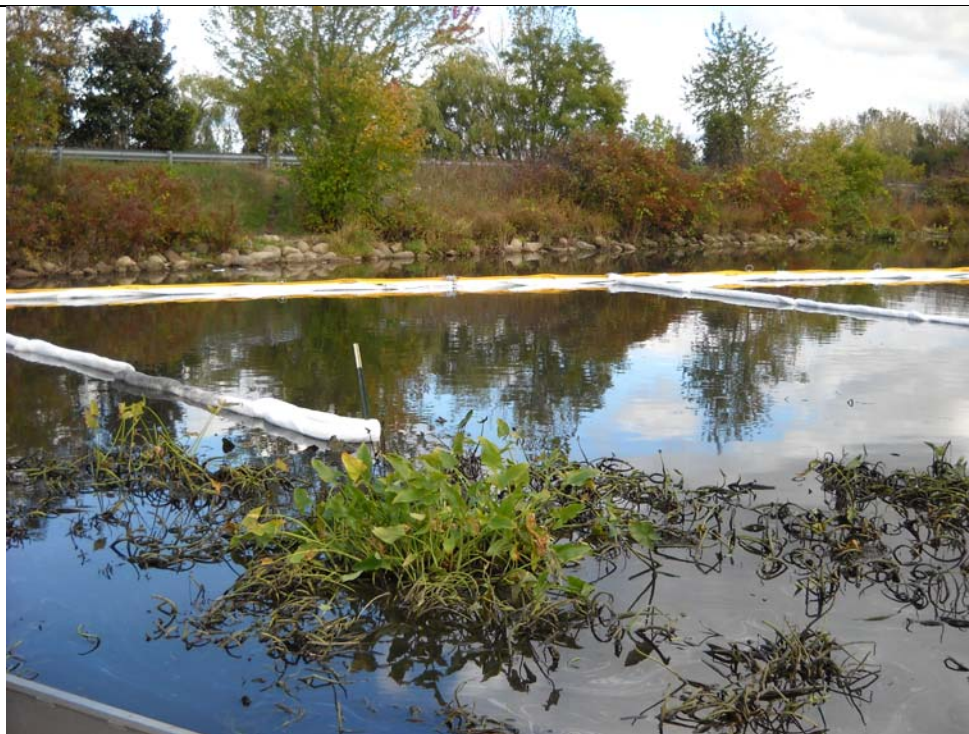
PHOTOGRAPH LOG
Photograph 5

Description:
Recovery activities in progress – hard and soft boom deployed

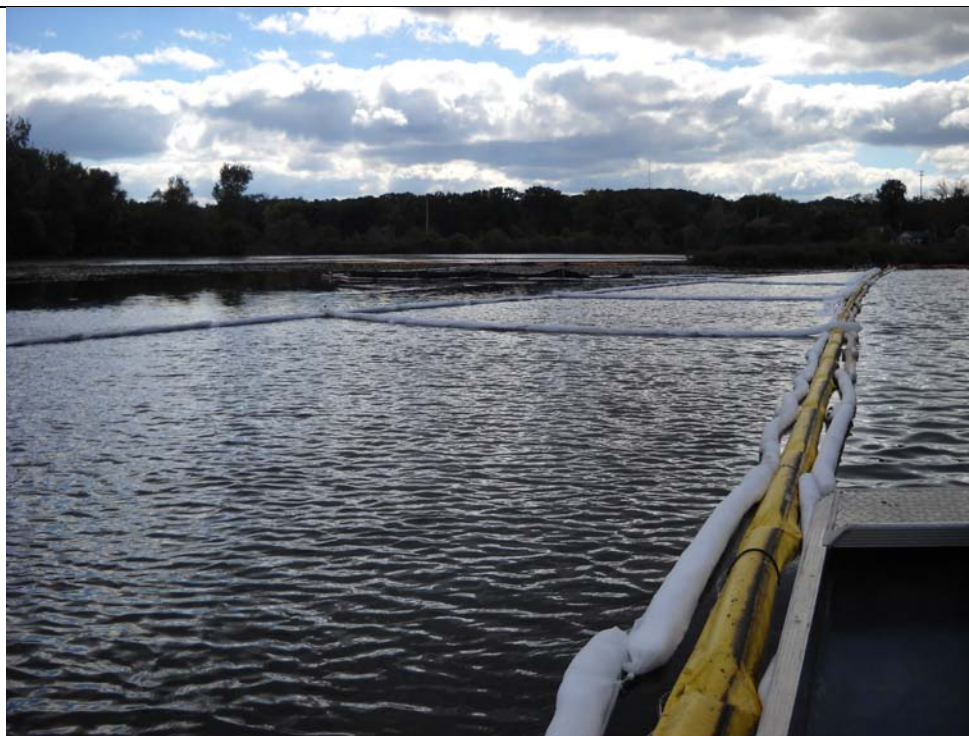
**PHOTOGRAPH LOG**
Photograph 6

Description:
Recovery activities in progress – hard and soft boom deployed

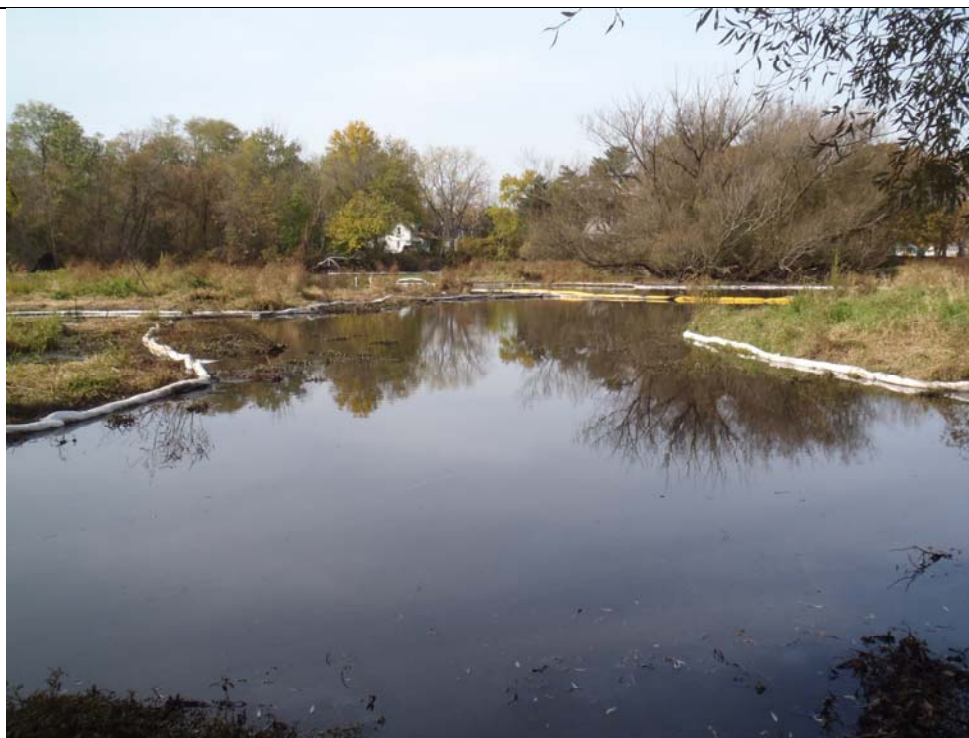
Photograph 7

Description:
Recovery activities
complete – boom ready to
be removed

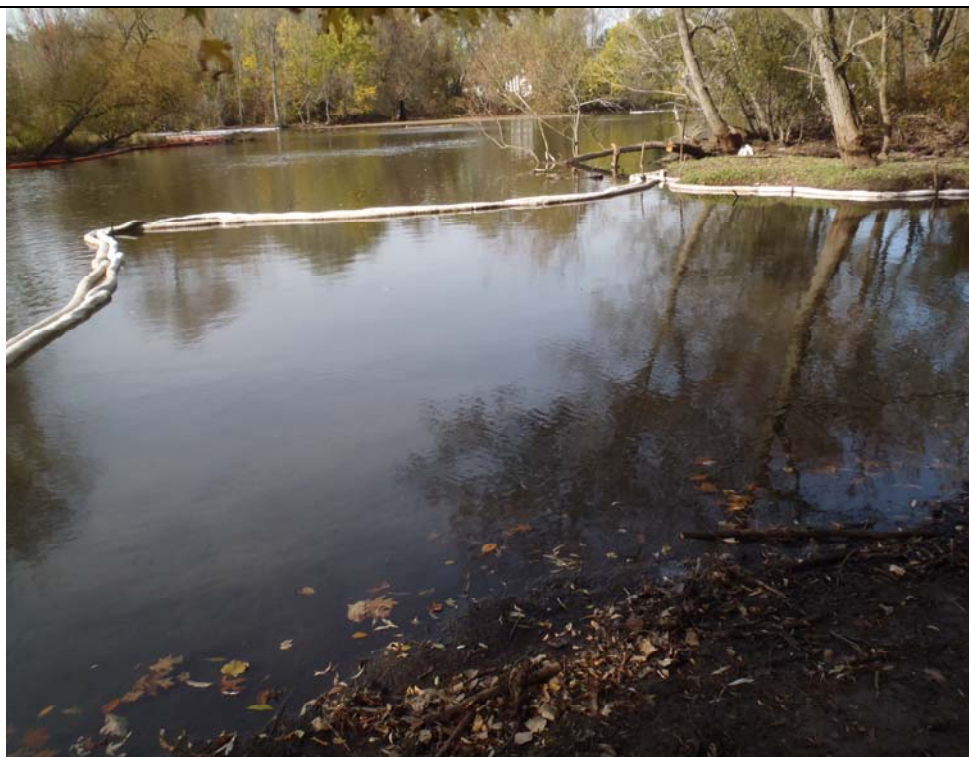
Photograph 8

Description:
Recovery activities
complete – boom ready to
be removed

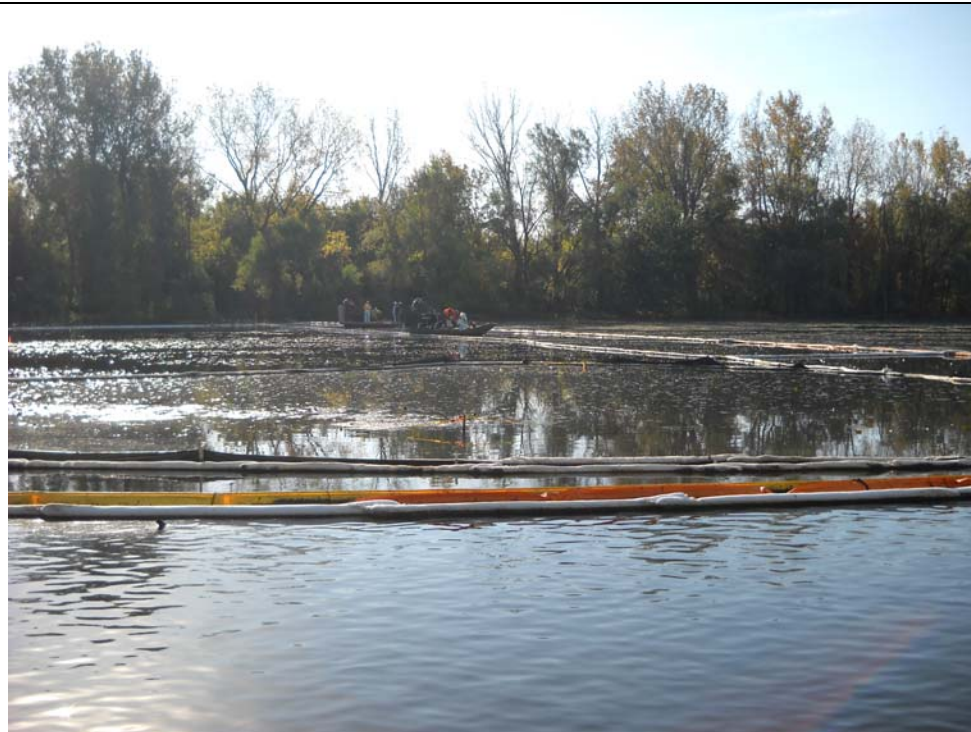
Description:
Recovery activities in
progress - water washing

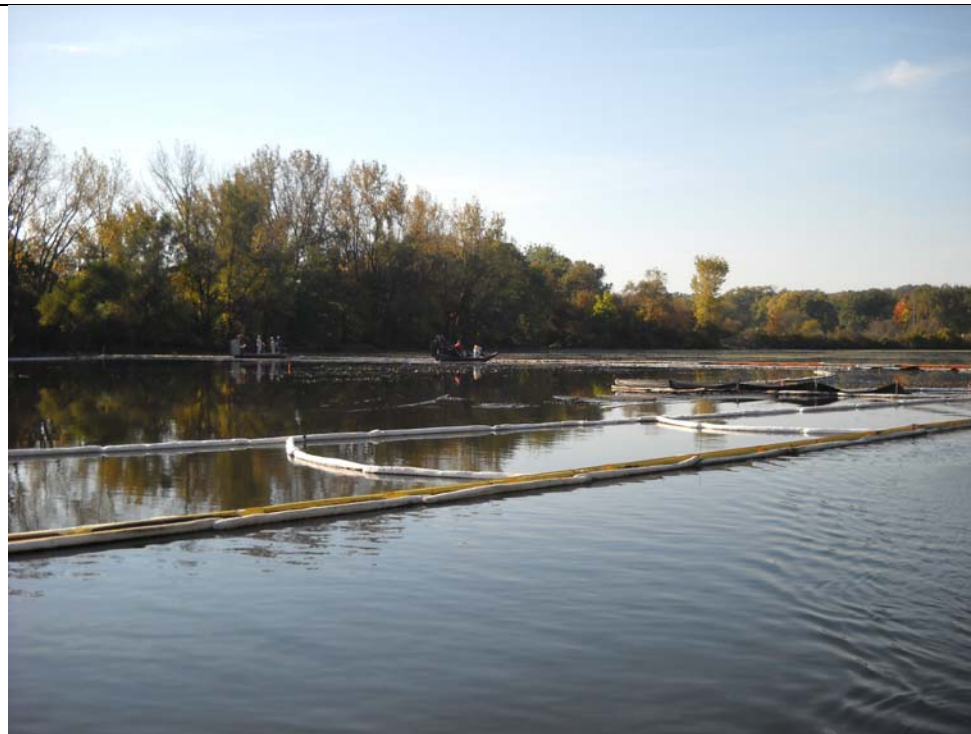
**PHOTOGRAPH LOG**
Photograph 2

Description:
Recovery activities in
progress - water washing

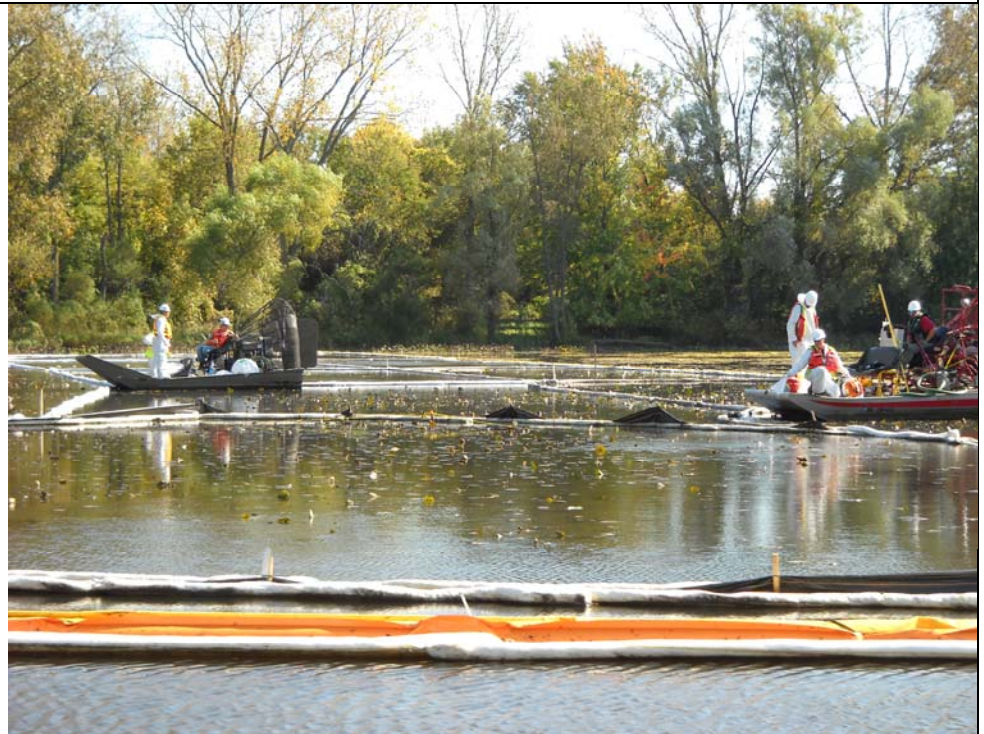
PHOTOGRAPH LOG
Photograph 3

Description:
Recovery activities in
progress - water washing

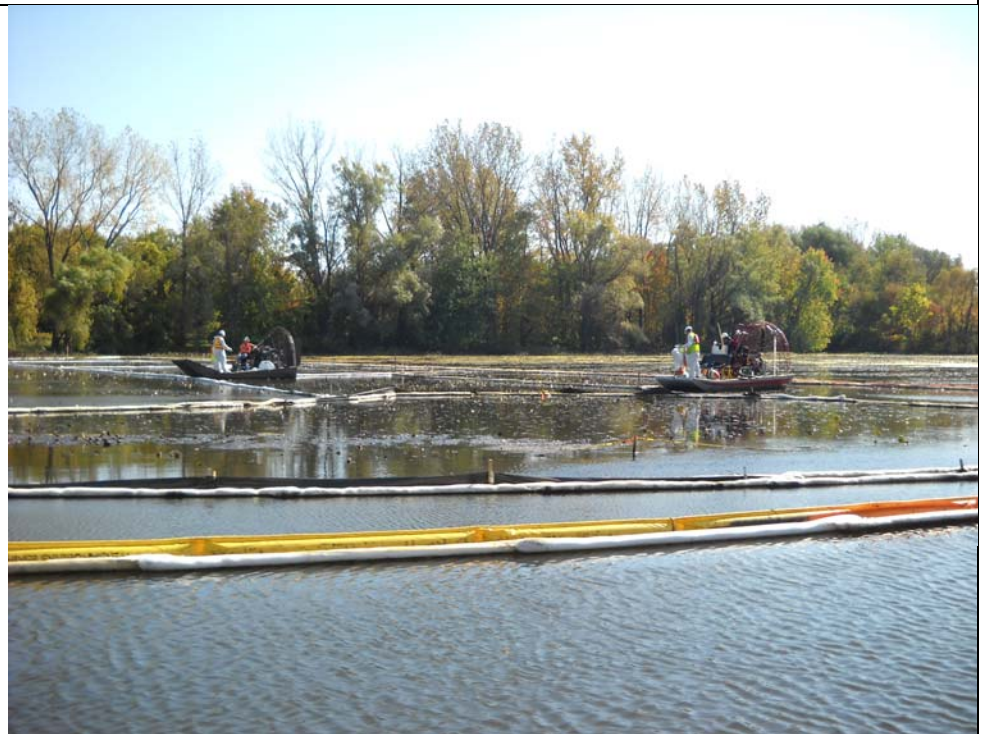
**PHOTOGRAPH LOG**
Photograph 4

Description:
Recovery activities in
progress – water washing

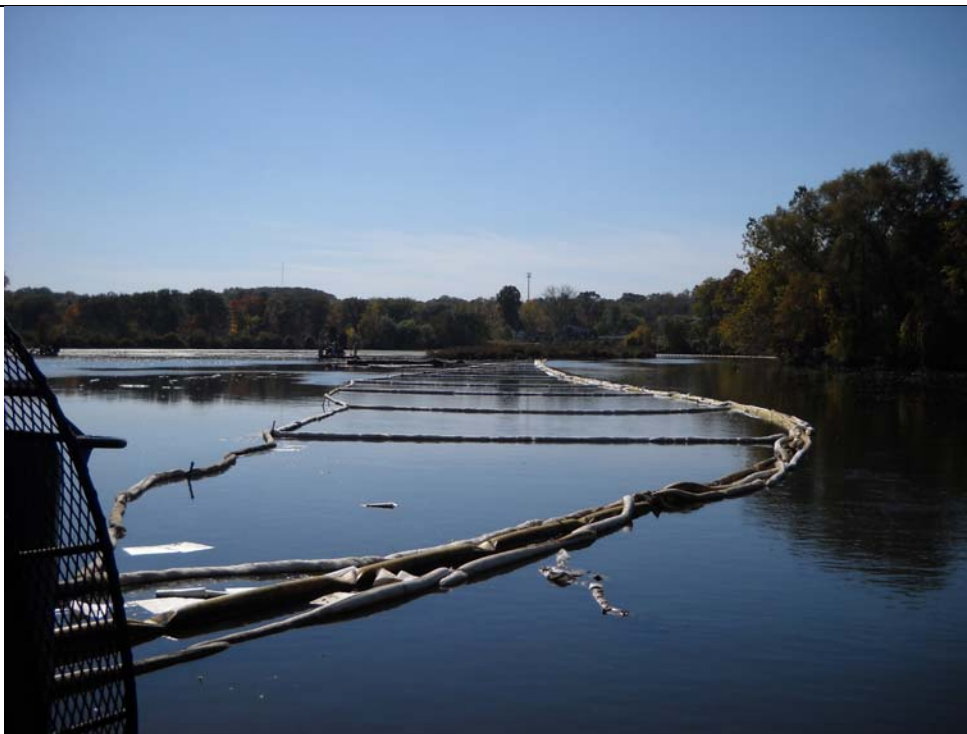
PHOTOGRAPH LOG
Photograph 5

Description:
Recovery activities in
progress - water washing

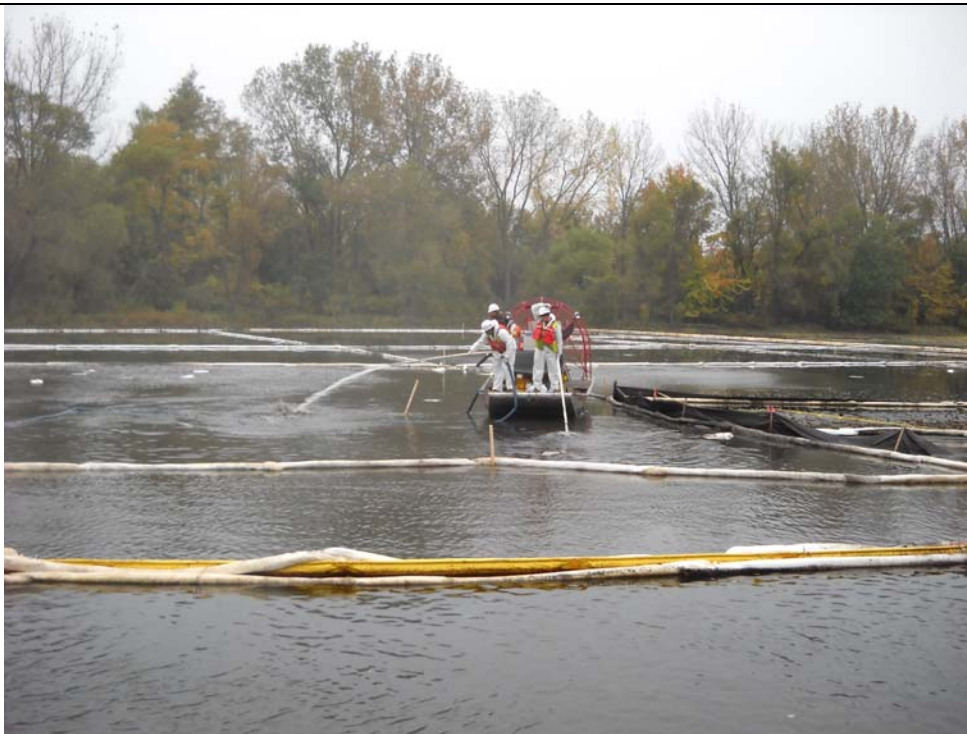
**PHOTOGRAPH LOG**
Photograph 6

Description:
Recovery activities in
progress - water washing

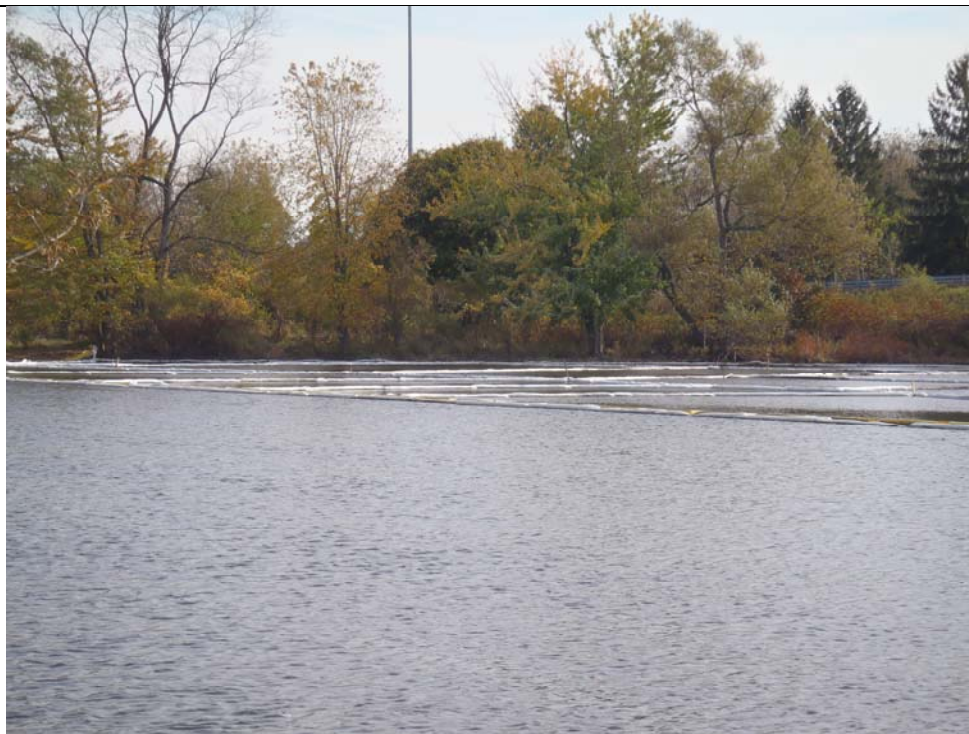
Photograph 7

Description:
Recovery activities
complete – containment
ready to be removed

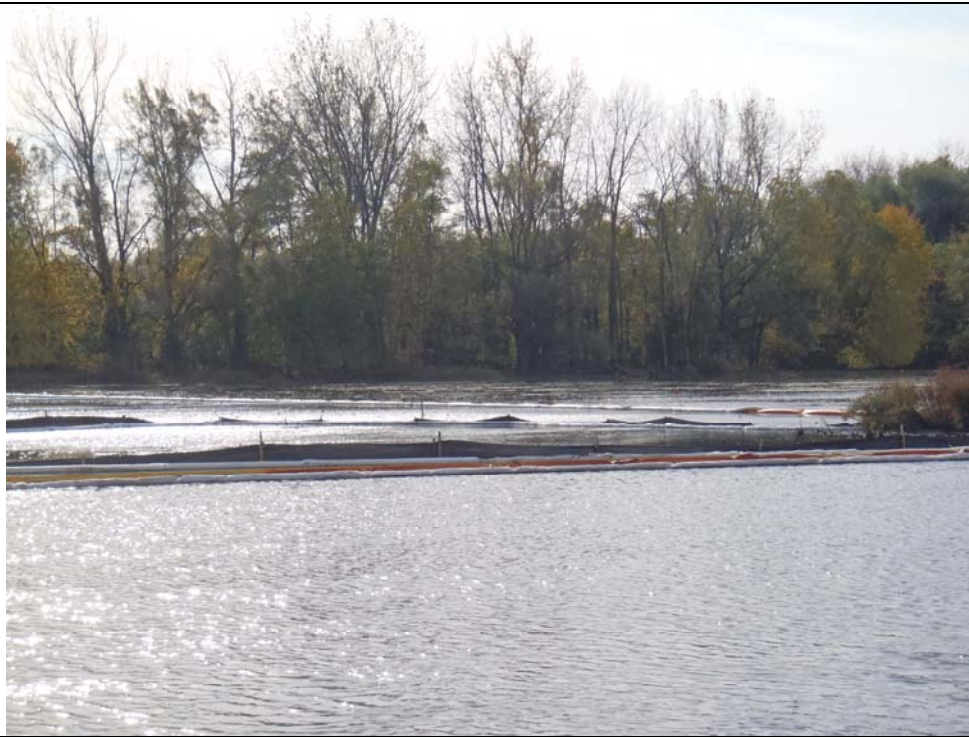
Photograph 8

Description:
Recovery activities
complete – containment
ready to be removed

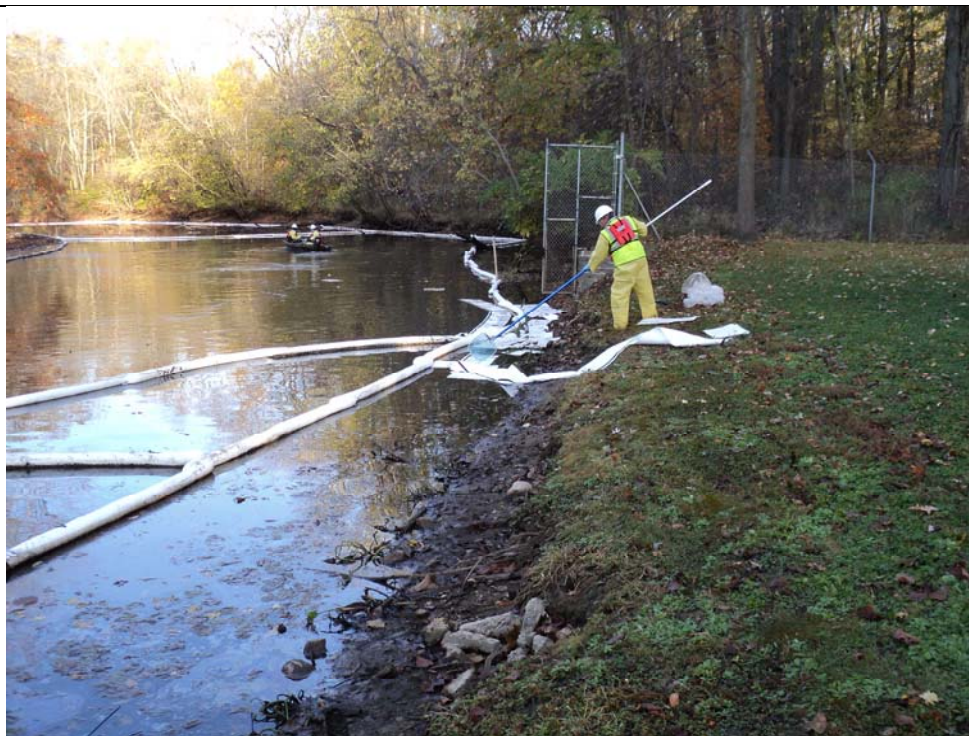
Description:
Recovery activities in progress – water washing and oil collection

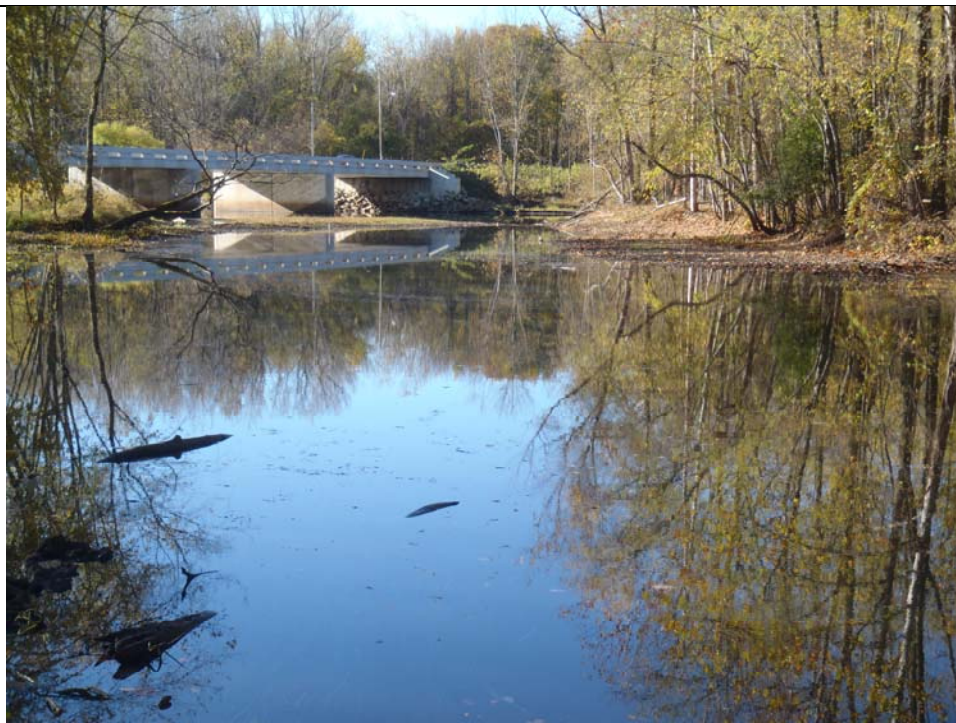
Photograph 3

Description:
Recovery activities
complete

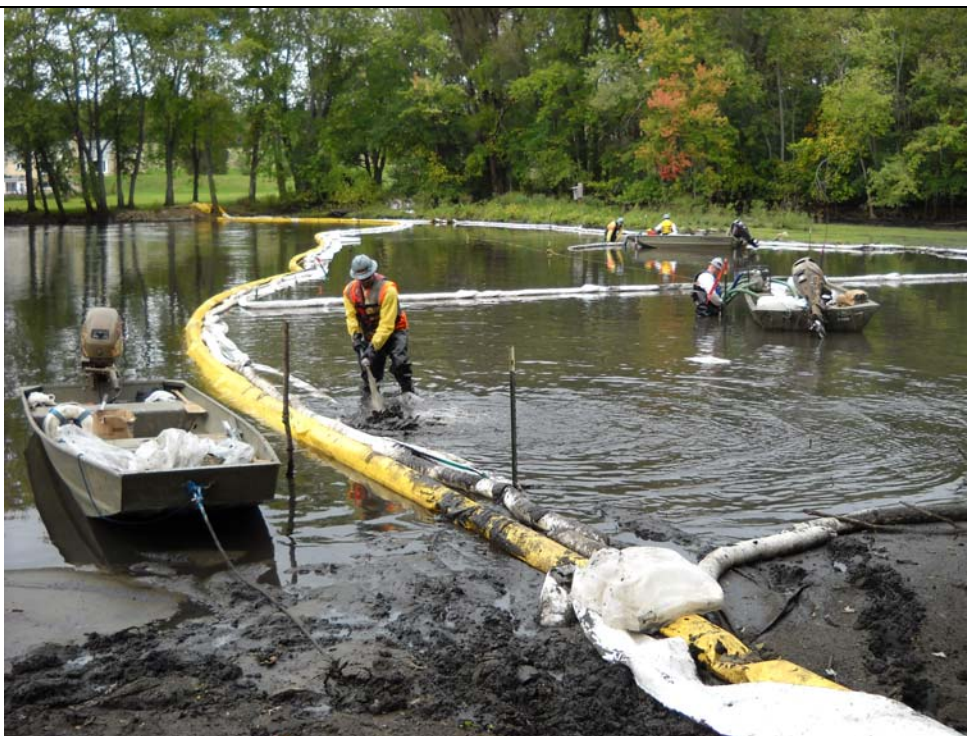
Description:
Recovery activities in
progress – water washing

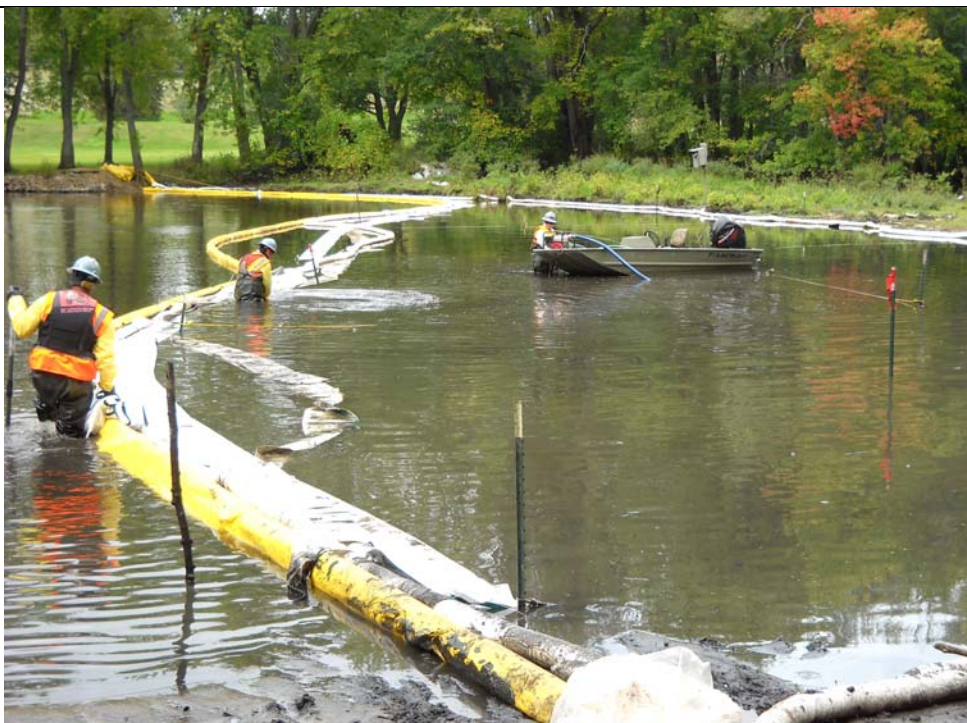
Photograph 2

Description:
Recovery activities in
progress - water washing

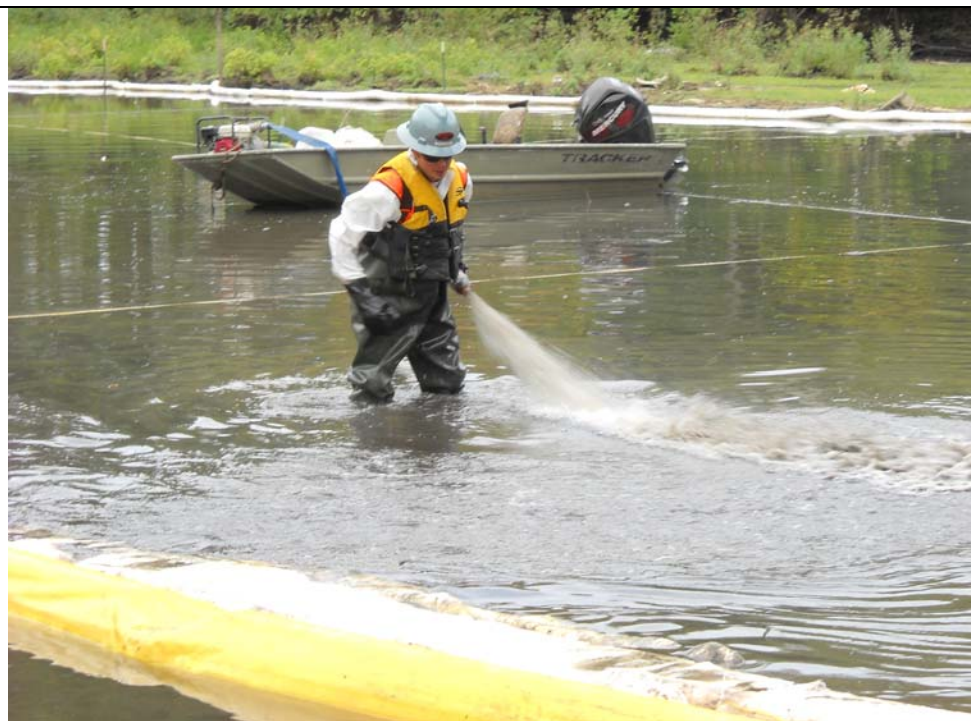
PHOTOGRAPH LOG
Photograph 3

Description:
Recovery activities in
progress - water washing

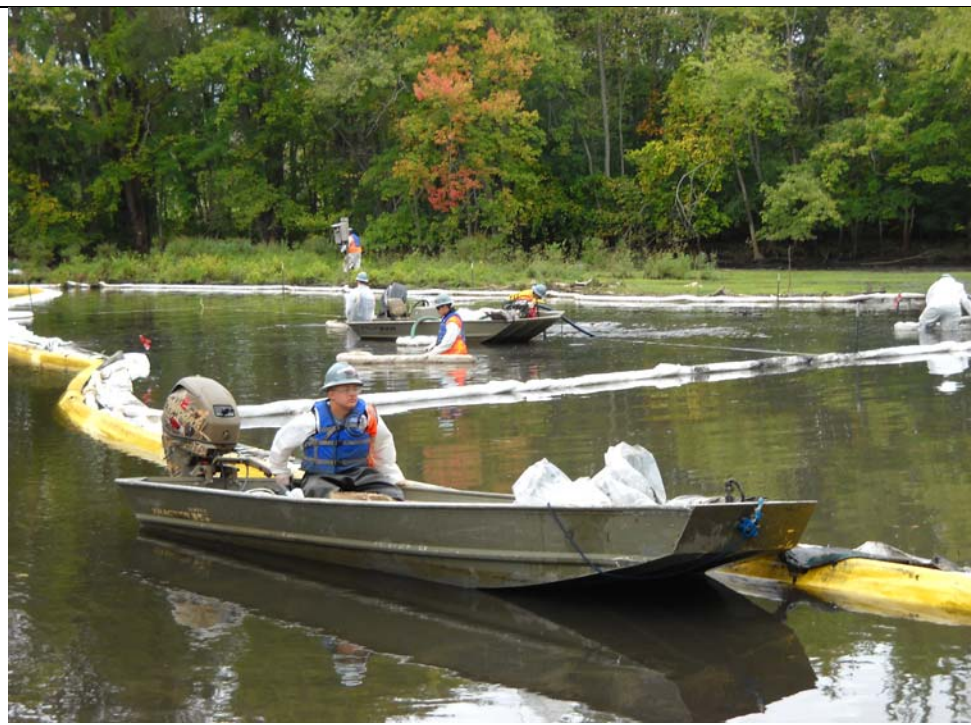
**PHOTOGRAPH LOG**
Photograph 4

Description:
Recovery activities in
progress - water washing

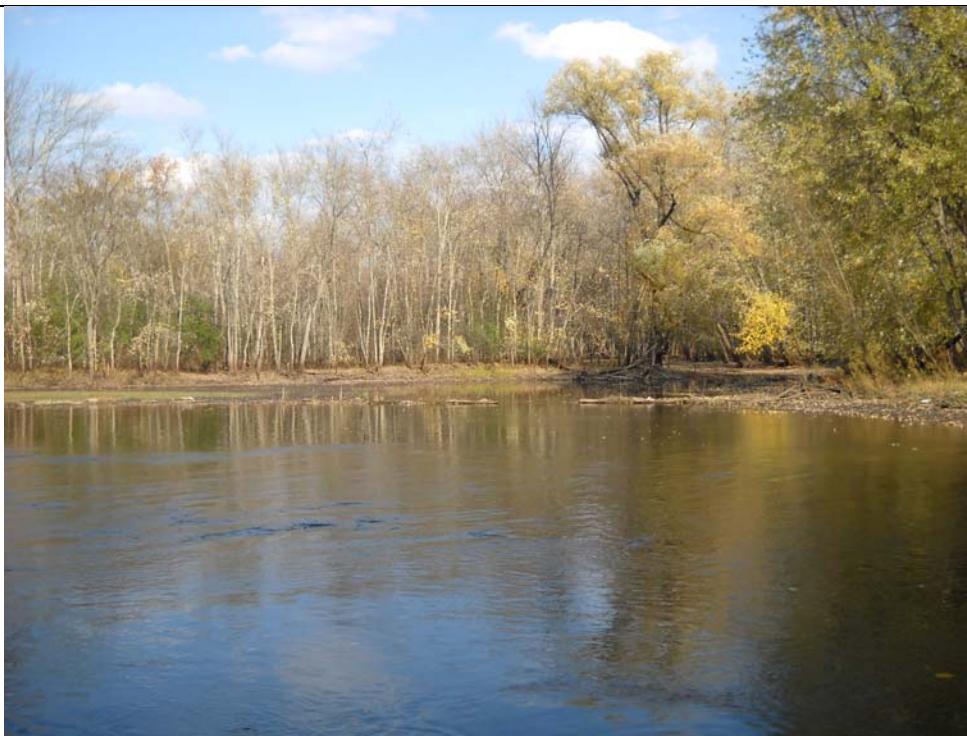
Photograph 5

Description:
Post Recovery – Activities
complete and containment
removed

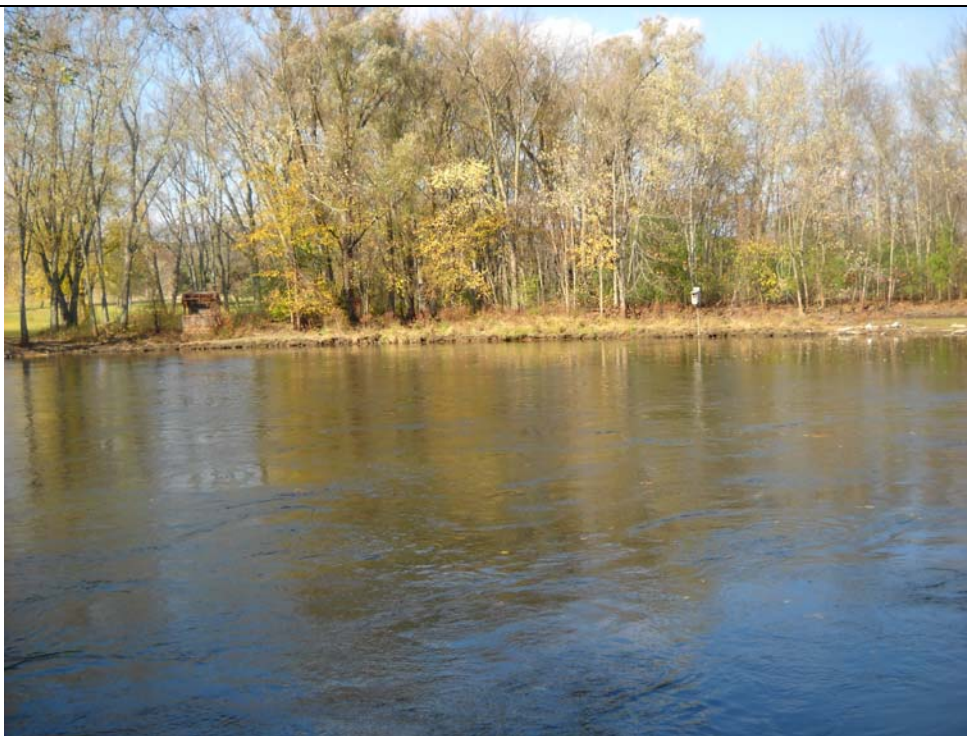
Photograph 6

Description:
Post Recovery – Activities
complete and containment
removed

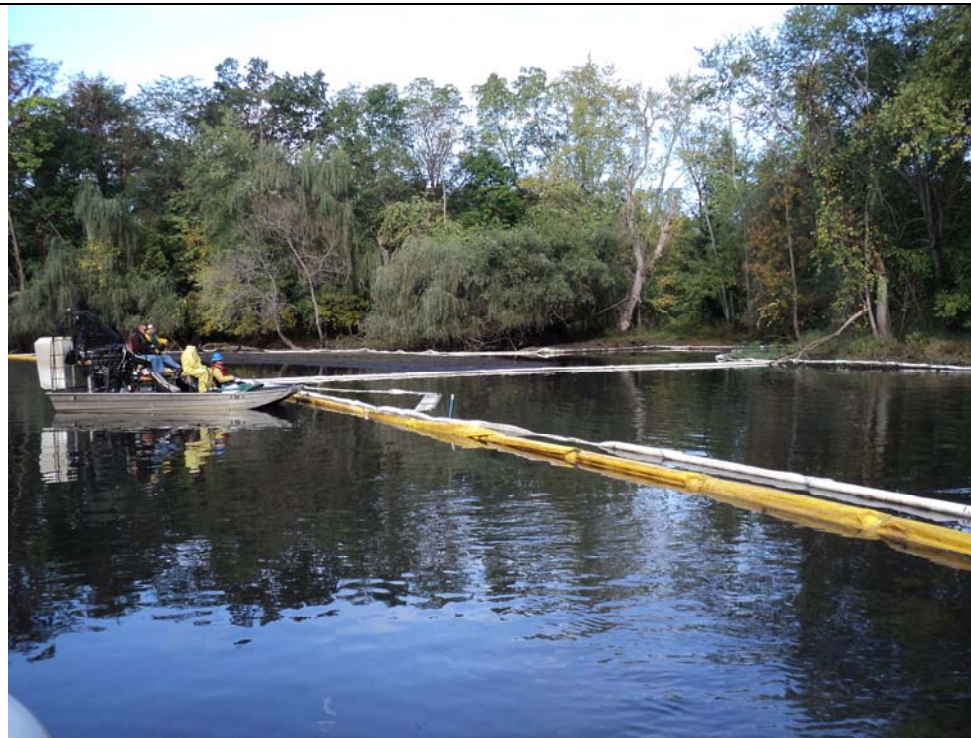
Description:
Recovery activities in
progress - water washing

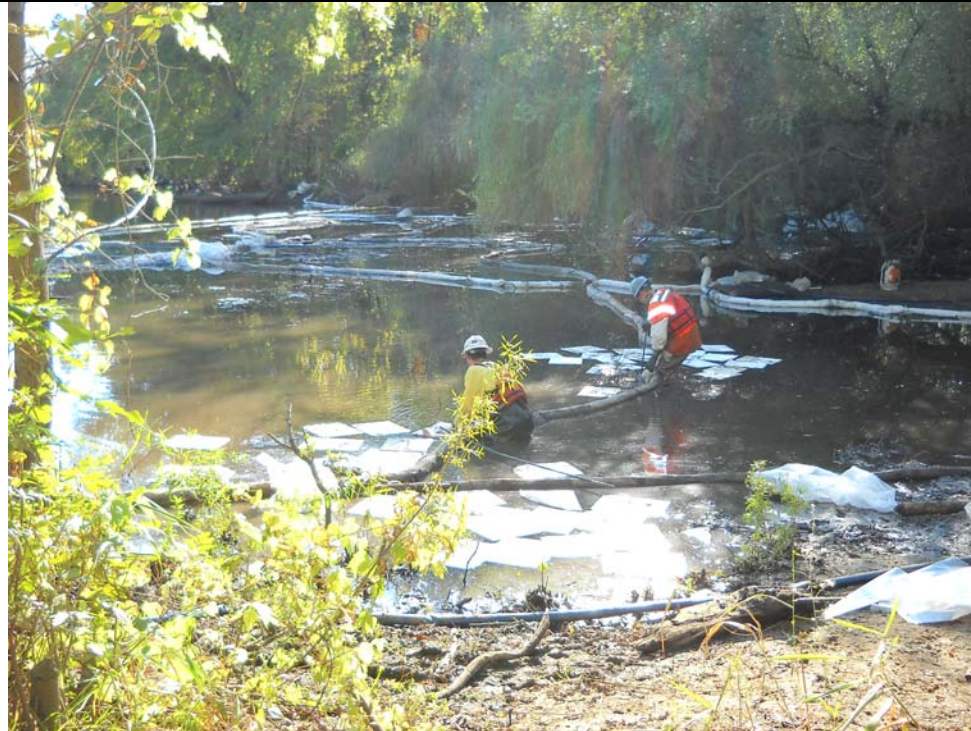
Photograph 2

Description:
Recovery activities in
progress – collecting
surfaced oil with pads

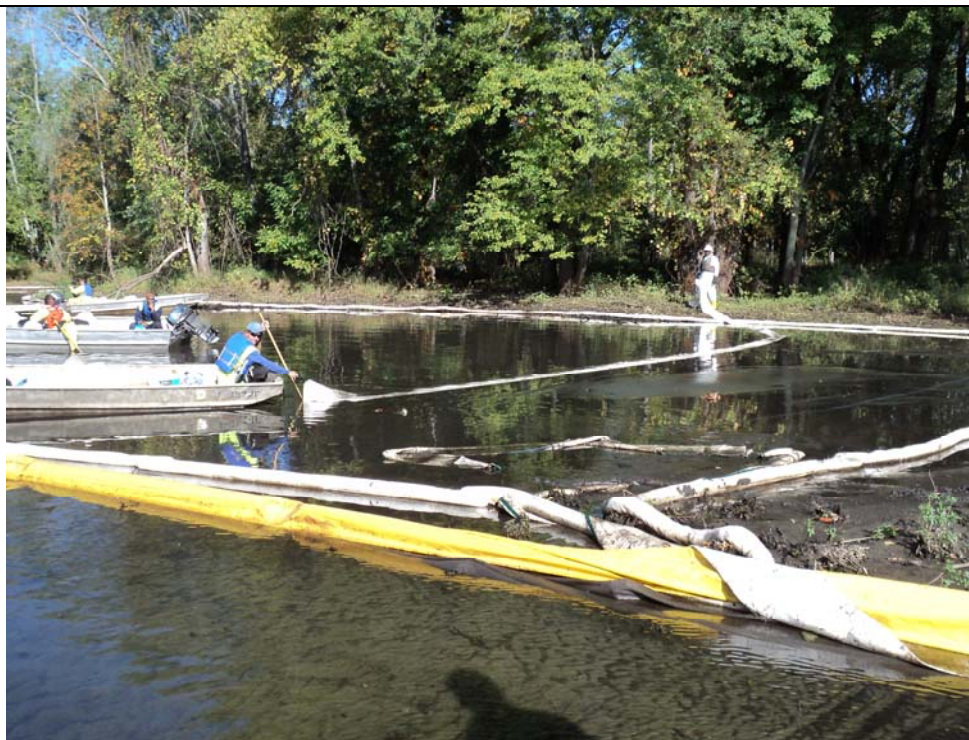
Description:
Recovery activities in
progress - water washing

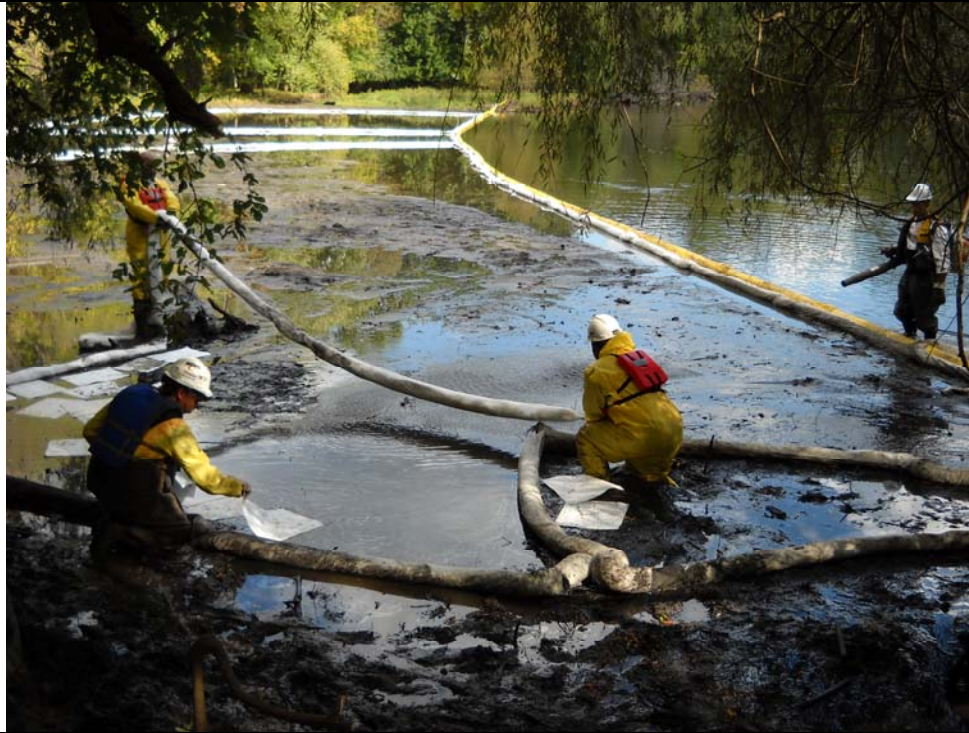
**PHOTOGRAPH LOG**
Photograph 4

Description:
Recovery activities in
progress – collecting
surfaced oil with pads

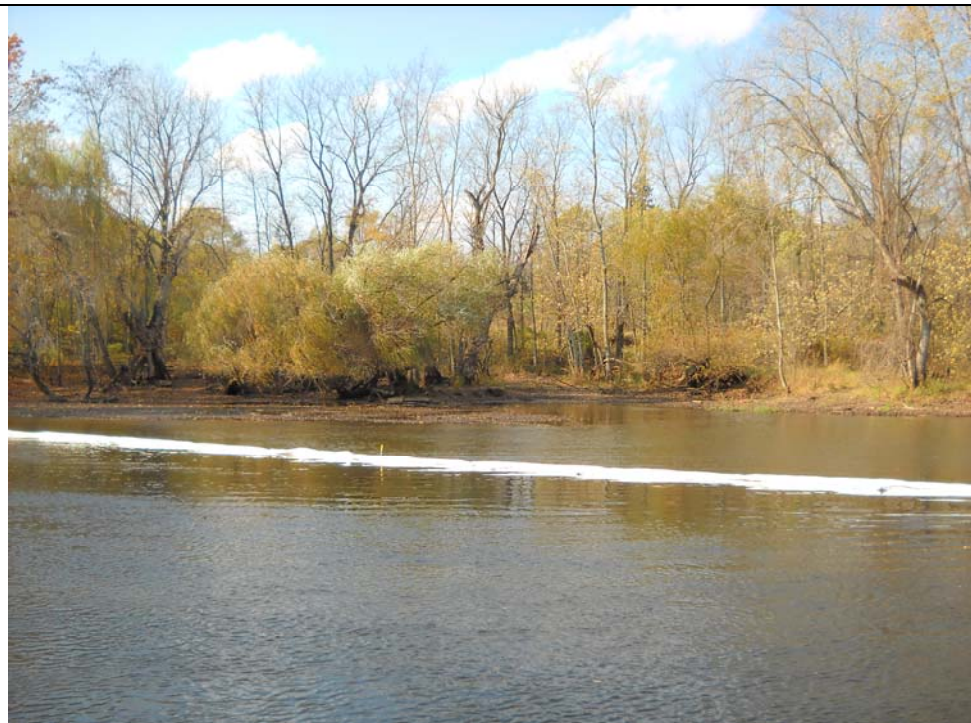
PHOTOGRAPH LOG
Photograph 5

Description:
Post Recovery – Recovery
activities complete – some
containment still in place

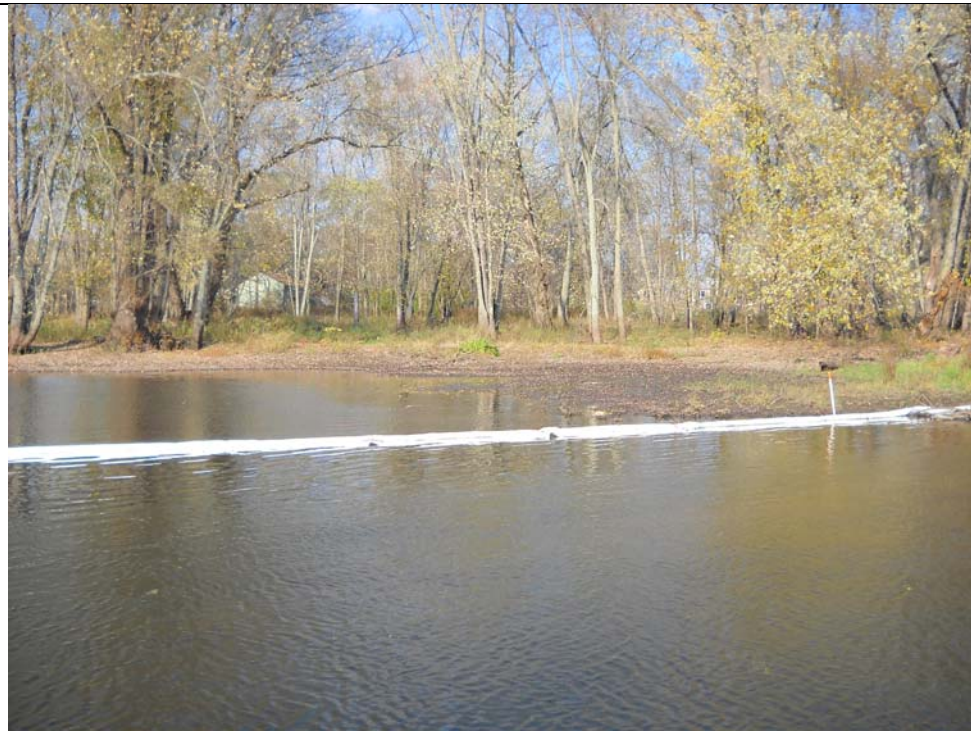
**PHOTOGRAPH LOG**
Photograph 6

Description:
Post Recovery – Recovery
activities complete – some
containment still in place

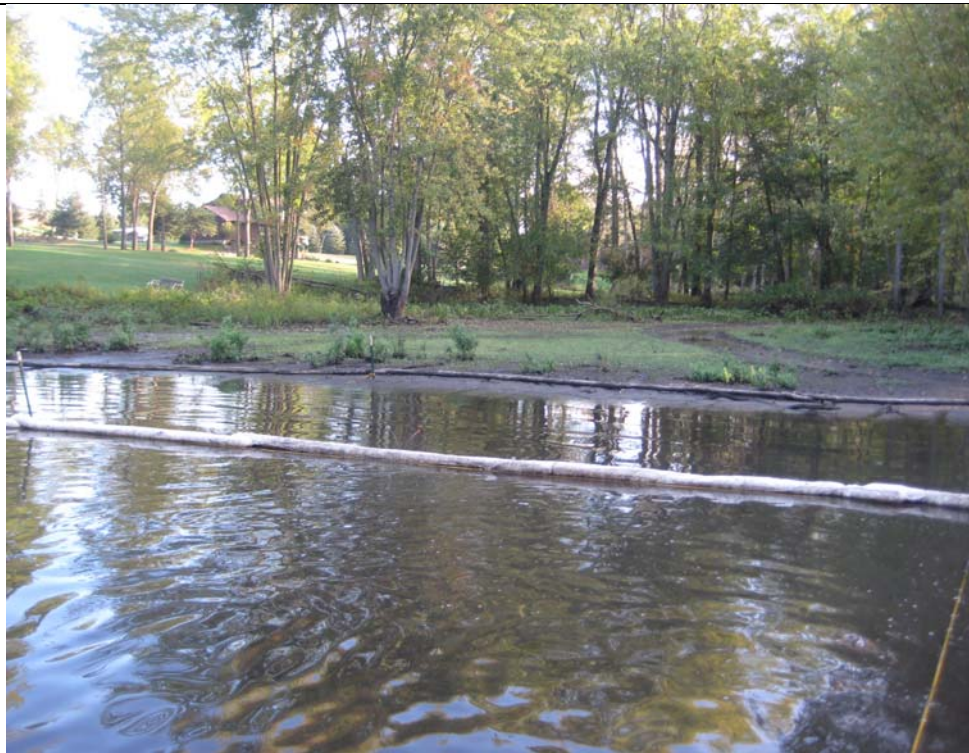
Description:
Recovery activities in
progress – cells prepared

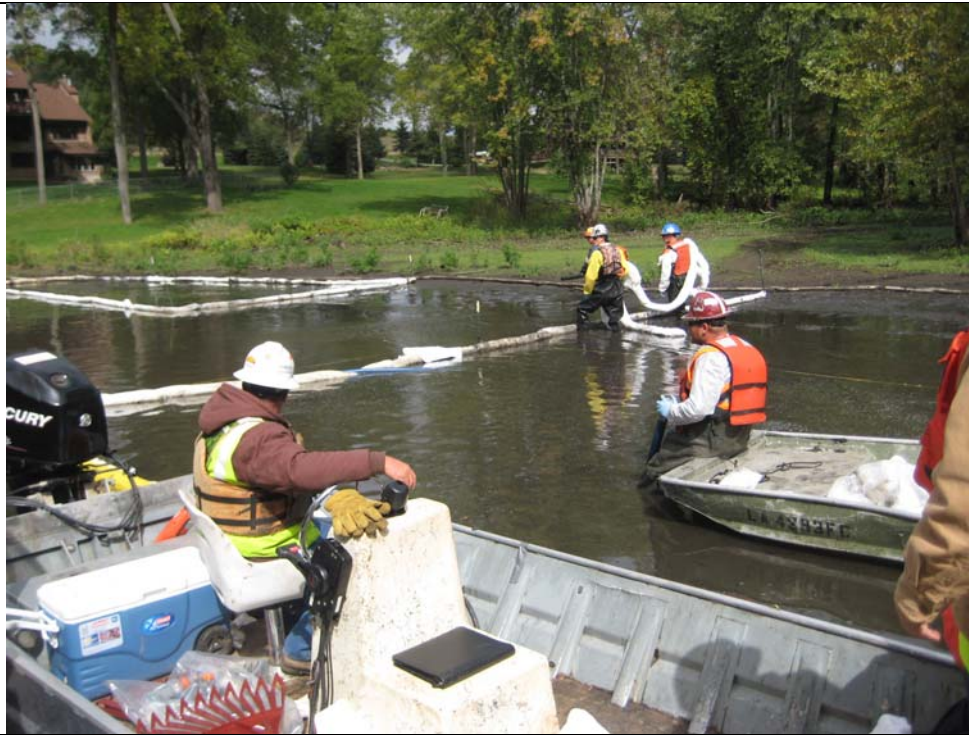
Photograph 2

Description:
Recovery activities in
progress - aeration

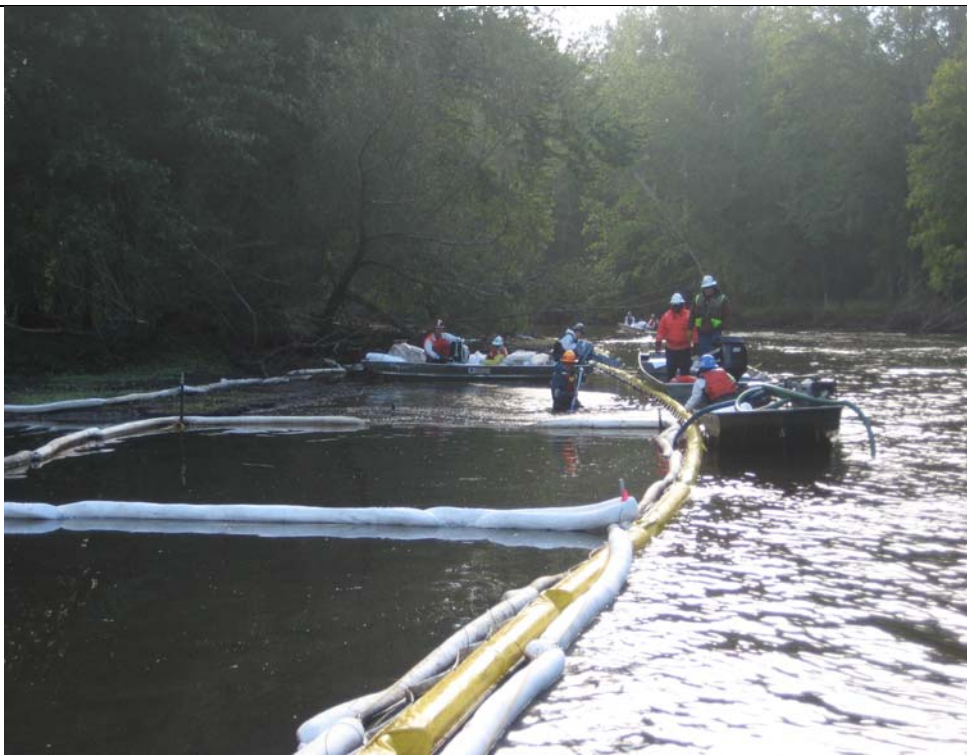
Photograph 3

Description:
Recovery activities in
progress - aeration
